Boskalis International bv

Reconstruction of breakwater in Arzew, Algeria

Client: Ministry of Public Works, Directorate for Basic Infrastructure
 Engineer: Nedeco (Netherlands)
 Location: Mediterranean Coast, Arzew (El Djedid), Algeria
 Period: 1986 – 1992

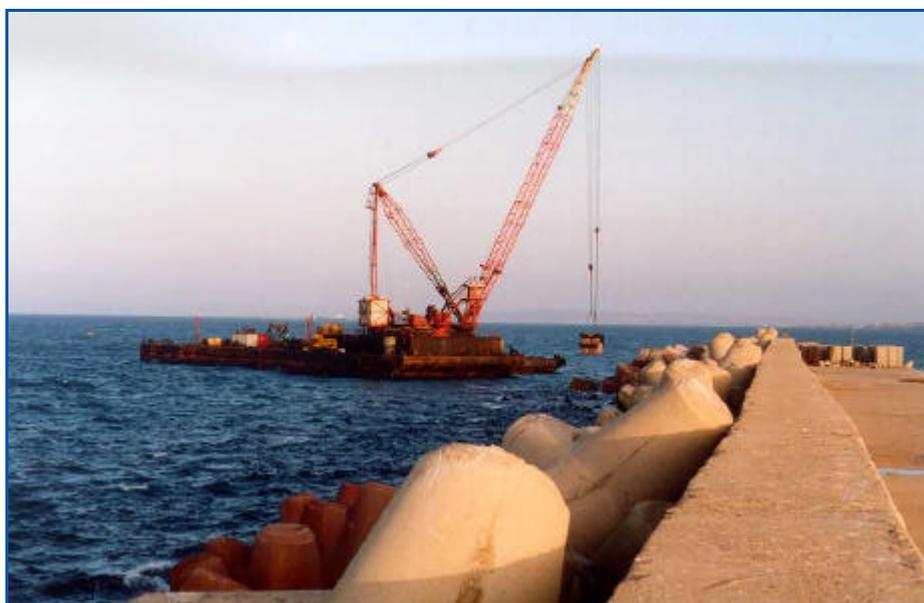
Left: placement of concrete elements;
 Right: summary of quantities.

150.000	m ² seabed clearance
115	mattresses, each measuring 30x50 metres
1.000.000	tons of quarry run
4.00.000	tons of filter stone, of 10-60 kg and 60-300 kg
3.00.000	tons of 0.2-1 ton rocks
4.00.000	tons of 1-3 ton rocks
7.00.000	tons of 4-6 ton rocks
19.000	concrete blocks of 12 tons each
22.000	concrete blocks of 40 tons each
1.500	concrete blocks of 60-65 tons each

stone and rock it was possible to start placing the concrete blocks. A total of 19.000 blocks (12 tons each) were placed along the toe of the breakwater using the floating crane and, partly, the stone dumper. For the breakwater slopes and the two ends, 22.000 larger concrete blocks of 40 tons each were placed, supplemented at both ends of the structure with 1.500 blocks of 60-65 tons each.

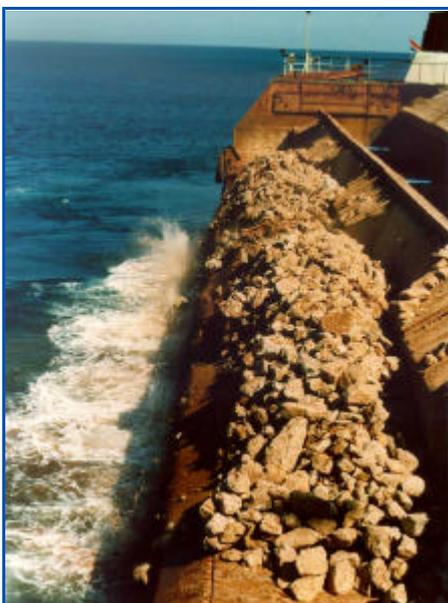
Left: spreading of filter stone;
Middle above: scheme of reconstruction of toe;
Middle under: Scheme of placement of concrete elements;
Right: handling of 65 tons elements.

With these initial stages of the project completed, reconstruction could begin in earnest. Some 400.000 tons of filter stone, of 10-60 kg and 60-300kg, was spread over the mattresses, followed by almost 400.000 tons of rock (weighing 1-3 tons) which formed the toe of the new breakwater construction. Next came 650.000 tons of quarry run, to build up the required breakwater profile, followed by 300.000 tons of 0.2-1 ton rocks and 700.000 tons of 4-6 ton rocks. All grades of material were placed within the tight tolerances stipulated in the design. During placement of the
